# NUMEX 2002: Excellence rewarded

*The winner and four other finalists in the NUMEX competition developed effective, cost-efficient solutions to a variety of maintenance problems at their nuclear power plants in Europe.*

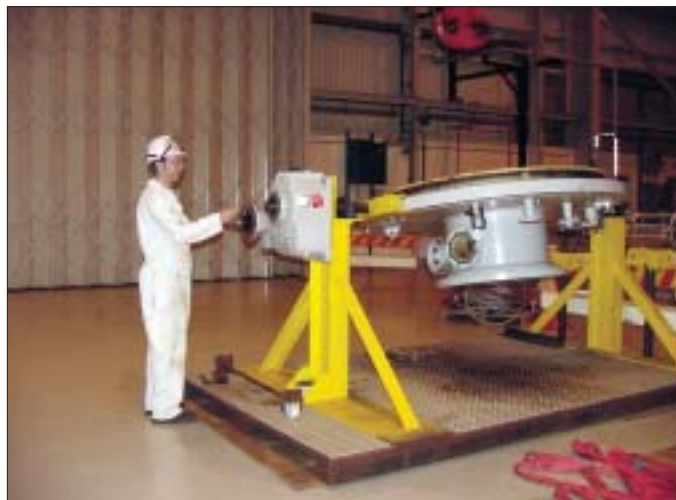
The turning rig for the ESW (essential service water) strainer lid developed by staff at Sizewell B (BE)

During removal of the ESW strainer lid, lifting slings were being cut when the lid was turned. The problem was that when using the crane to turn the strainer lid, bolt holes had to be used as lifting points, and the slings were rigged to them, since there were no designed lifting points.

The solution was to design a purpose-built mechanical means to hold the strainer lid so that it could be turned in a controlled manner. The turning rig was made to accommodate the strainer lids from both the ESW system and the auxiliary cooling water (ACW) system. The rig allows mechanical work to be completed, as well as new coatings to be applied on the underside of the lid in a safe manner.

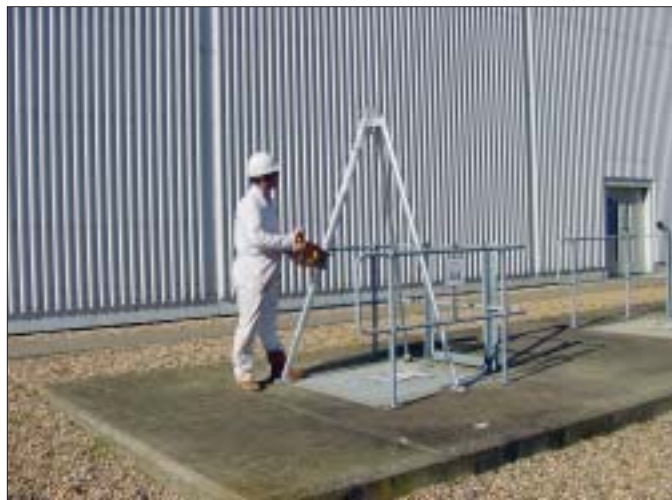
A tripod lifting frame for removal of sump pumps from cable tunnels (BE)

Some of the cable and pipe tunnels at Sizewell can only be accessed via vertical ladders. The tunnels have installed sump pumps that can be removed only by lifting up through access hatches. Previously the lifting was carried out manually. The team identified a tripod lifting frame after seeing a television program on work being carried out within sewers, where the tripod was used as a rescue aid. The tripod was successfully tested at the site, and a unit was purchased.

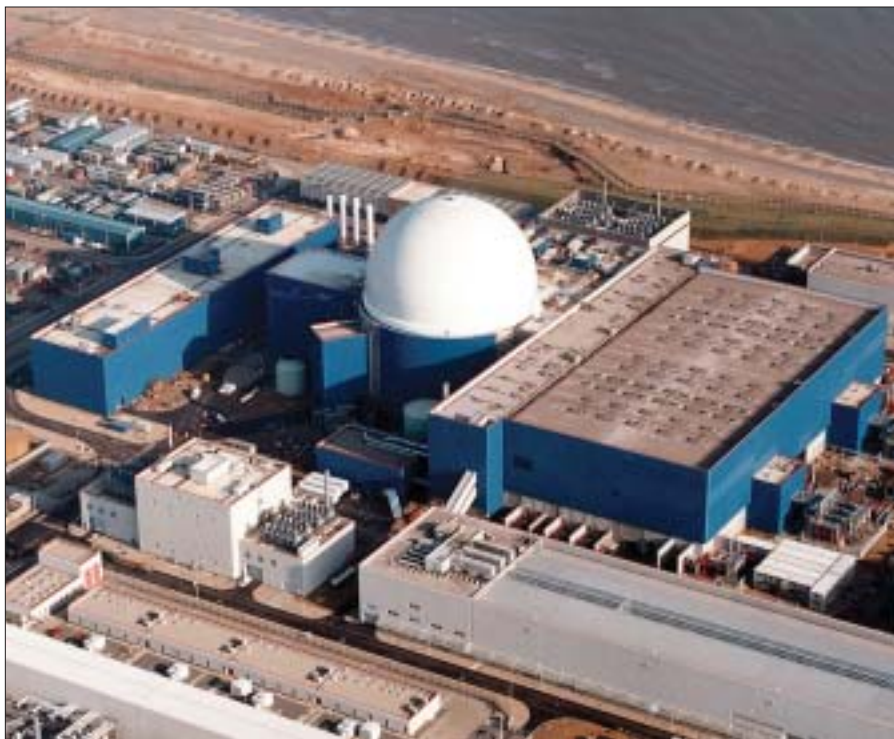
**Sizewell B:** Solutions to maintenance operations concerns lead to a win

Previously, when the main feedwater system strainer for maintenance was being disassembled, the strainer had to be lifted clear of the body and turned from a vertical to a horizontal position. Because the top of the strainer is very heavy, there was an unbalanced load when turning it was attempted.

The team proposed removing the top of the strainer while it was still in the strainer body, simplifying the whole disassembly operation. This could be achieved by man-

ufacturing supports for the strainer that would hold it in position while the top was removed. The systems engineer agreed to the solution, and produced a new lifting procedure for the task.

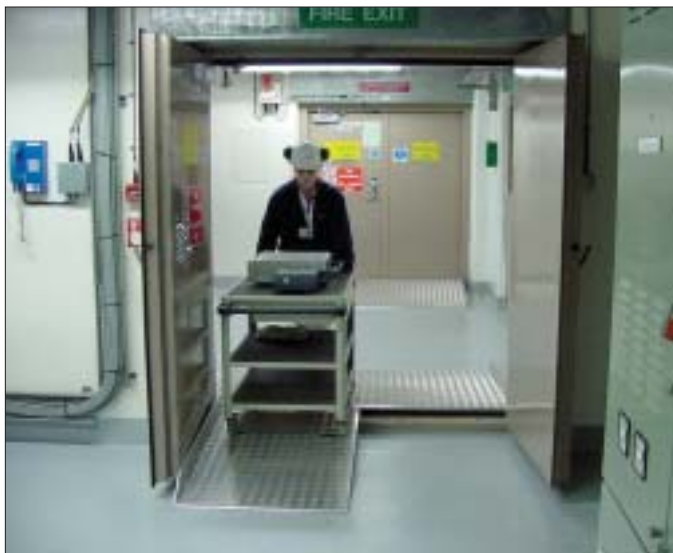
A team identified the solution of using purpose-built ramps to enable lifting trolleys for SPS/PPS (secondary protection system/primary protection system) circuit breakers to be moved over a high-integrity fire door with a large step built into it. (BE)

For seismic concerns, the lifting trolleys for the SPS/PPS circuit breakers are not stored in the circuit breaker rooms. When moving the trolleys in the rooms, it is necessary to pass through a high-integrity fire door that has a large step built into it. The trolleys are heavy and had to be manually lifted over the step to get them into the breaker room. The team identified a simple solution of having purpose-built ramps made that could be removed after use, thus removing the manual-handling issue.

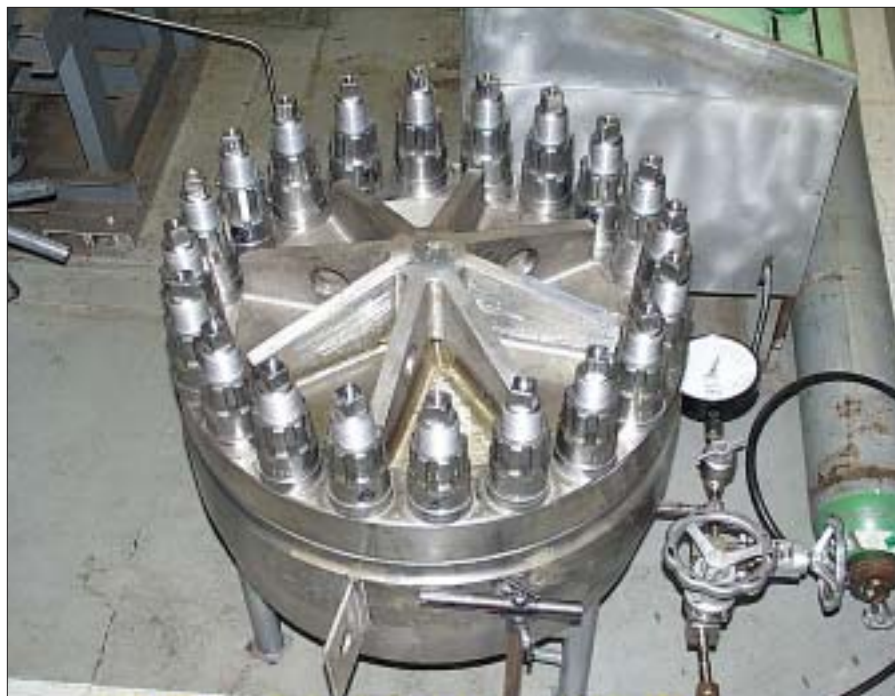
Testing of the new stainless steel gasket ring that seals the steam generator header covers at Dukovany (CEZ)

A seal was then made and tested on a full-scale test bench, which used one of the replaced headers. For all tests, the bolts were tightened by a force of about 200 kN, about 26 percent less than the force required for the original nickel rings. Different sizes of the graphite foils and different modifications of the packing ring were also tested.

The test results confirmed that the new sealing system meets the requirements of leak-tightness. In fact, the measured leakage at the reduced force indicated that the modified sealing was approximately twice as leakproof as the original sealing. In addition, calculations of the sealing behavior during all possible operating conditions (including emergency) were performed by the Institute of Applied Mechanics.

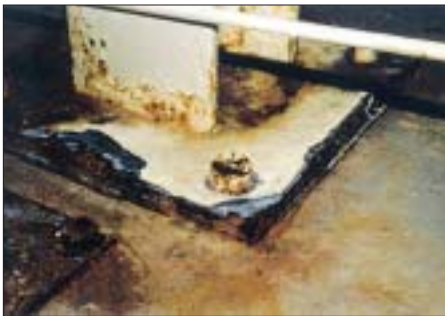
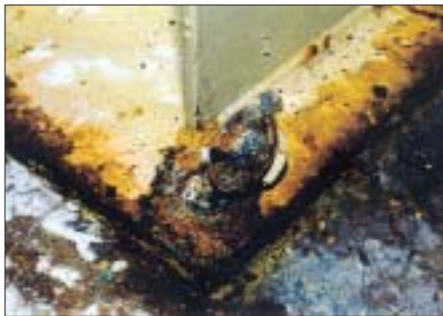
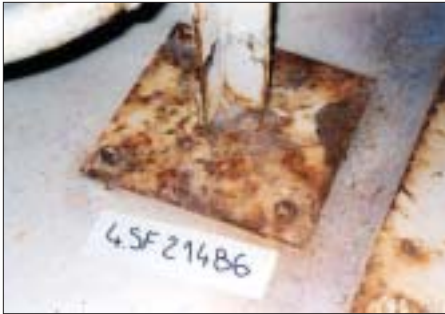
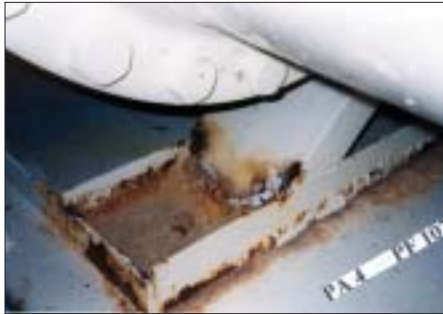
Corrosion and aging phenomena—as shown in the photos above—if unrecognized, can put the plant at risk. (EdF)

There are often only minimal warning signs of potential problems. Maugey particularly cited corrosion and aging phenomena, which can go unrecognized, putting the plant at risk. For example, Paluel faces the English Channel, which presents a highly corrosive environment for

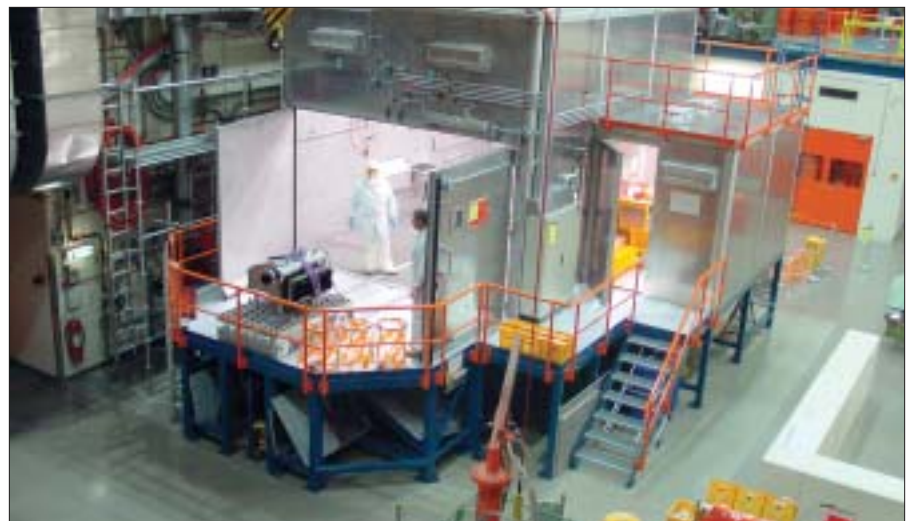
New Decontamination Box facility at Leibstadt (Photo: Kernkraftwerk Leibstadt AG, Switzerland)

The new Deconbox was designed in close collaboration with the decontamination workers to ensure that all requirements and applications were considered from the point of rates and helping achieve the company goal of outage durations of only 16 days. The designers came up with the following dimensions for the Deconbox: area,  $6 \times 4$  m; height 4 m; a dressing room of  $2 \times 4$  m; and loading platform of  $3 \times 4$  m.

- A decontamination-friendly design.
- Inside surfaces all of stainless steel.
- A 5-cm lead shield inside the 10-cm-thick wall (reducing outside dose rates by a factor of 7).
- Back-flushing equipment.
- Special transport wagon, making handling and decontamination of components easier.
