STP's first-of-a-kind leakage repair

BY EDWARD CONAWAY

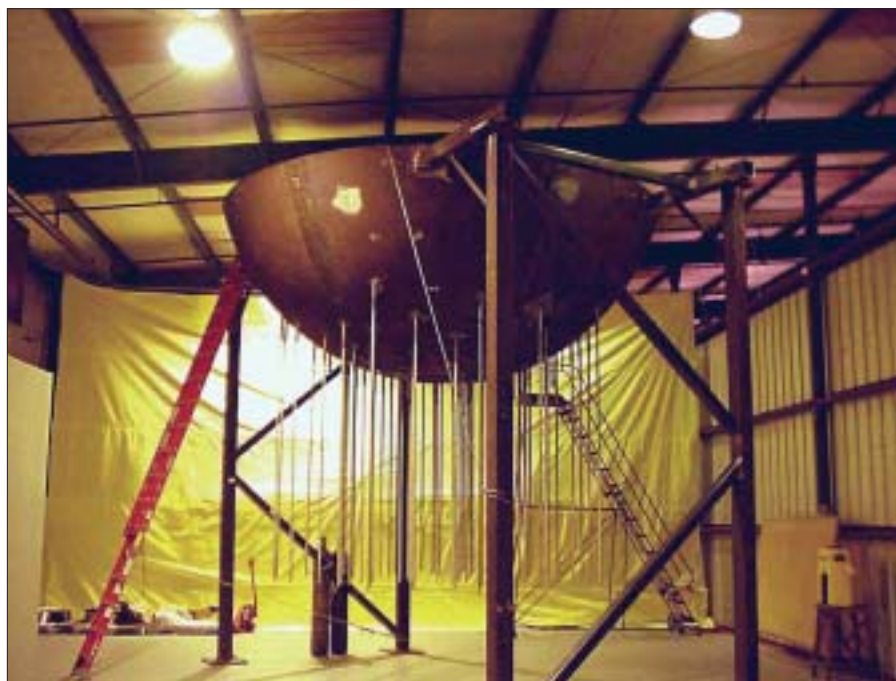
A mock-up of the lower half of STP-1's reactor vessel was used on-site by workers to practice various tasks before the real repair job was done. The long pipes descending from the reactor are instrumentation tubes. (Source: STP Nuclear Operating Co.)

Before implementation, the STP repairs were practiced and refined using a full-scale mock-up of a reactor vessel bottom. New shielding methods were rehearsed, together with various ways to reduce repair time, resulting in more than a 60 percent reduction in actual radiation exposure for repairs.

Reducing radiation exposure to its lowest possible amount was a goal of the BMI project from the start. A number of innovative as well as traditional techniques were used to minimize exposure. One innovation was STP's use of a full-scale mock-up of a reactor vessel bottom, complete with instrument tubes, fabricated in pie-shaped sections that were assembled on site. Workers were able to practice repairs in a dose-free area, and during training

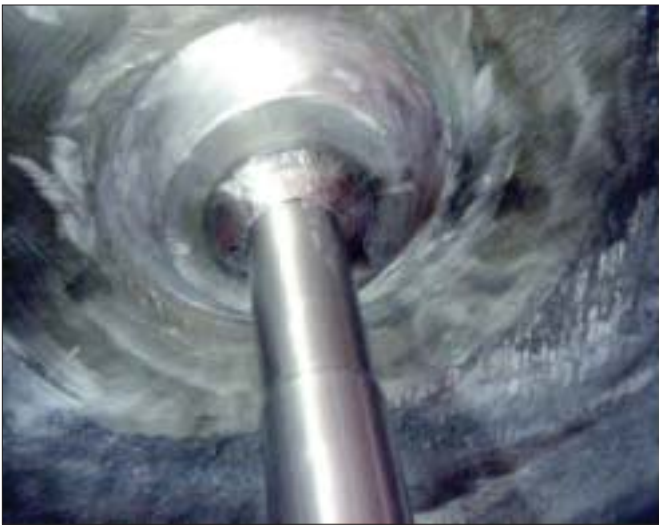
A close-up of a repaired nozzle, which was secured to the outside of the reactor by welding it to a thick, nickel-chromium pad. (Source: STP Nuclear Operating Co.)

The nozzles were repaired by removing their lower portions and replacing them with new nozzles made of the more corrosion-resistant Alloy 690. The new nozzles were secured by welding them to thick, nickel-chromium pads on the outside of the vessel. This "half-nozzle replacement" method had previously been employed on vessel heads and reactor pressurizers in the United States, and the NRC had reviewed and approved the method's use for those applications.
