# Fort Calhoun's "Big Outage"

# An inside look at Fort Calhoun's “Big Outage”

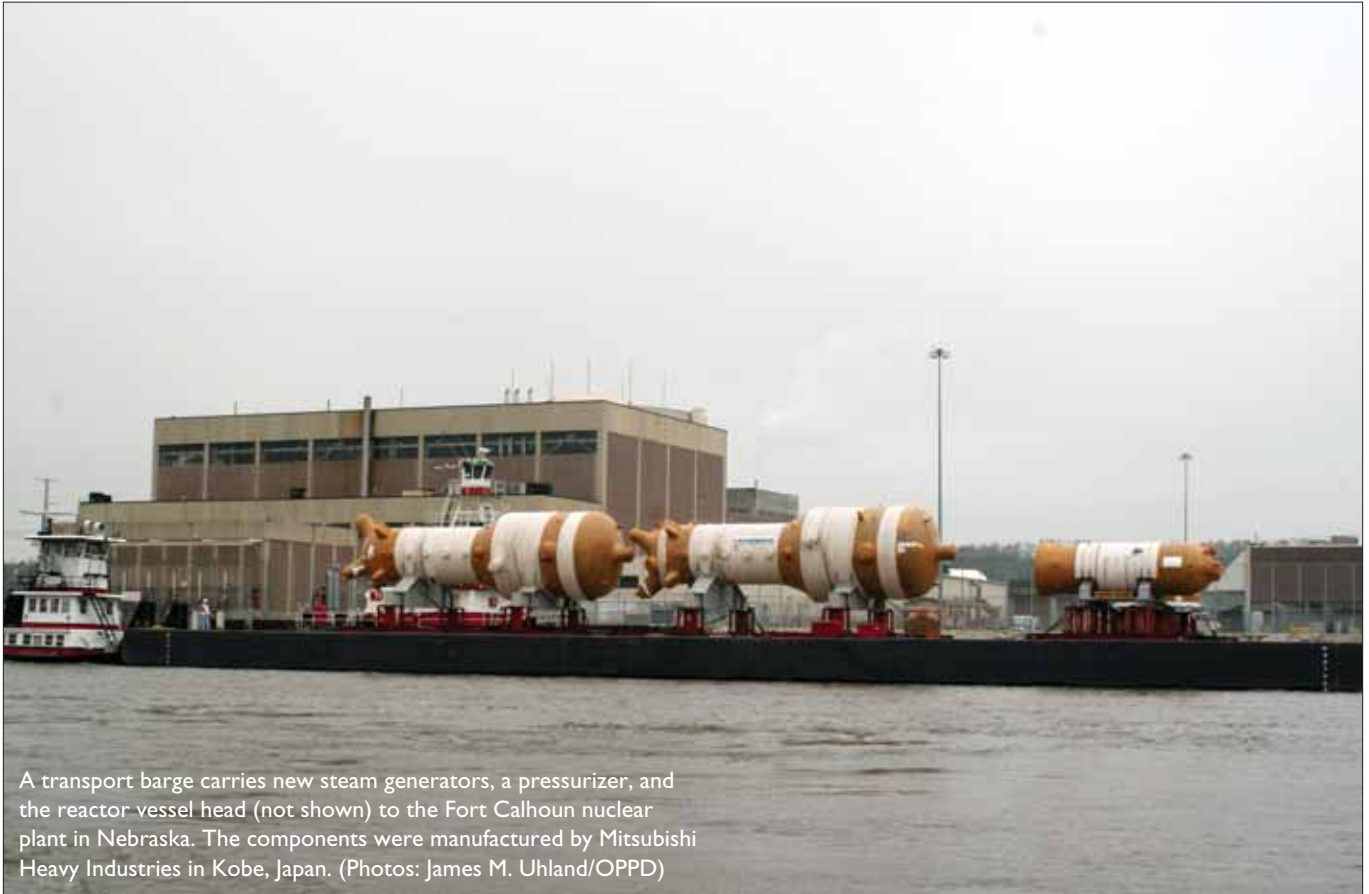
A transport barge carries new steam generators, a pressurizer, and the reactor vessel head (not shown) to the Fort Calhoun nuclear plant in Nebraska. The components were manufactured by Mitsubishi Heavy Industries in Kobe, Japan. (Photos: James M. Uhland/OPPD)

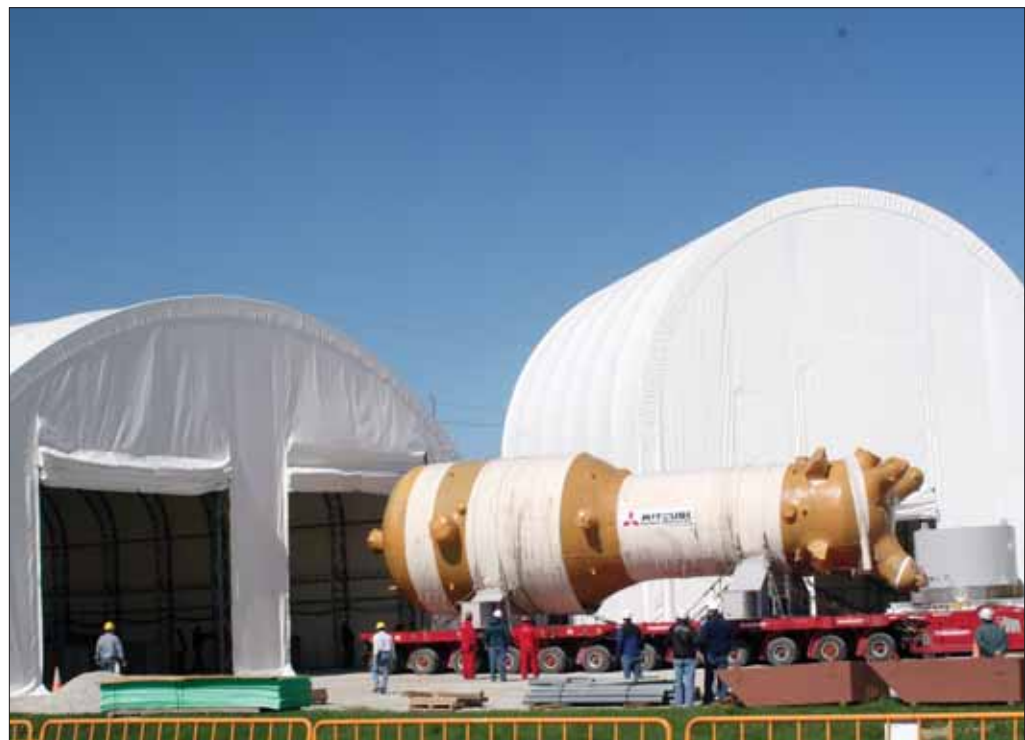
**Right:** The new steam generators are taken directly from the transport barge to a temporary storage tent on site.

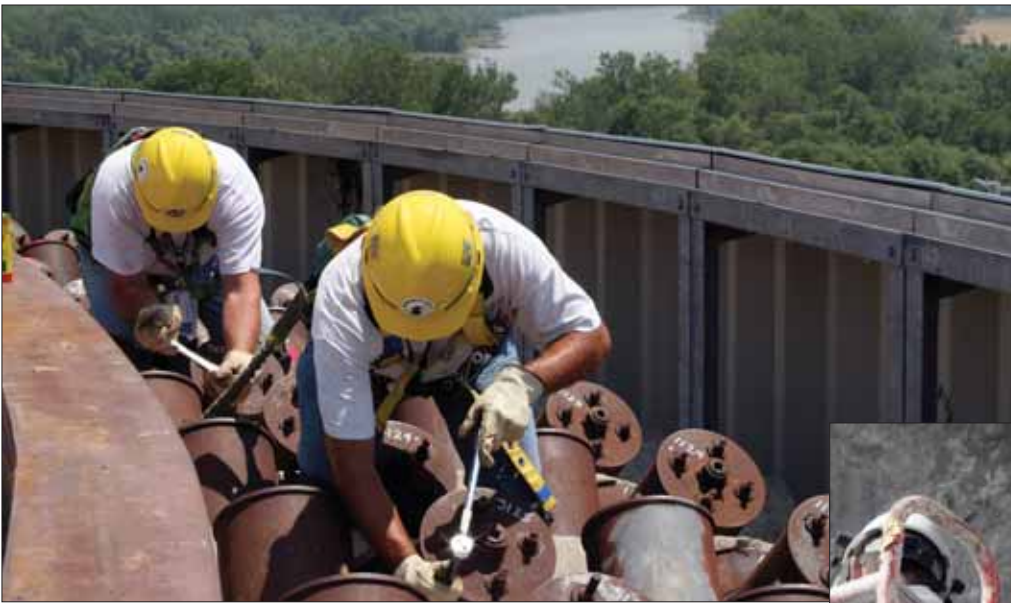
**Left:** Workers loosen tendons on the top of Fort Calhoun's containment building before their removal so that an opening can be created in the side of the containment building. The tendons are used as just one measure to keep the containment building tight and secure, similar to twine tied around a package.

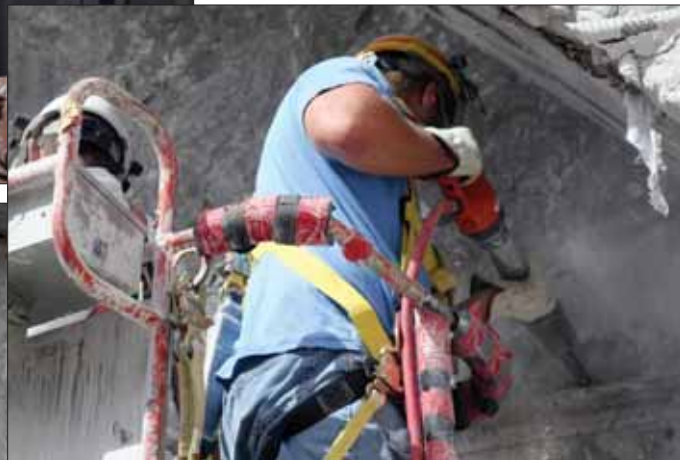
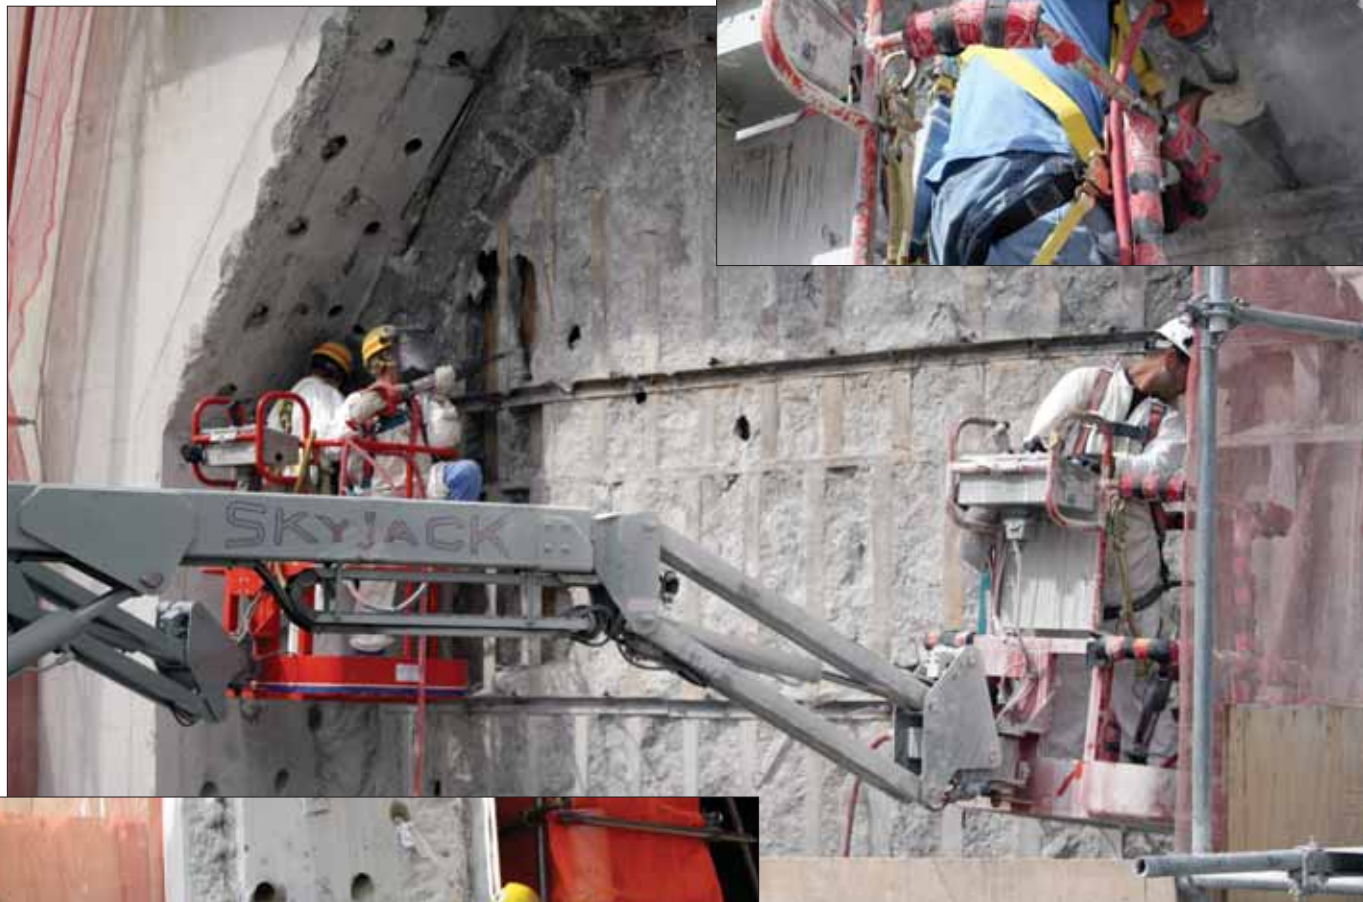
**Above & Inset:** In order to cut the opening in the containment building, workers use jackhammers to remove the final few inches of concrete surrounding the rebar that is part of the containment's liner.

One major step in replacing the main components was creating an opening in the containment building large enough to accommodate the massive equipment that would be moved in and out of the building. Because the walls of the containment building consist of four-foot-thick reinforced concrete, this was no small task. The process of cutting through the containment wall took about a week. Workers accomplished the task using industrial-sized jackhammers, cutting torches, and smaller jackhammers.

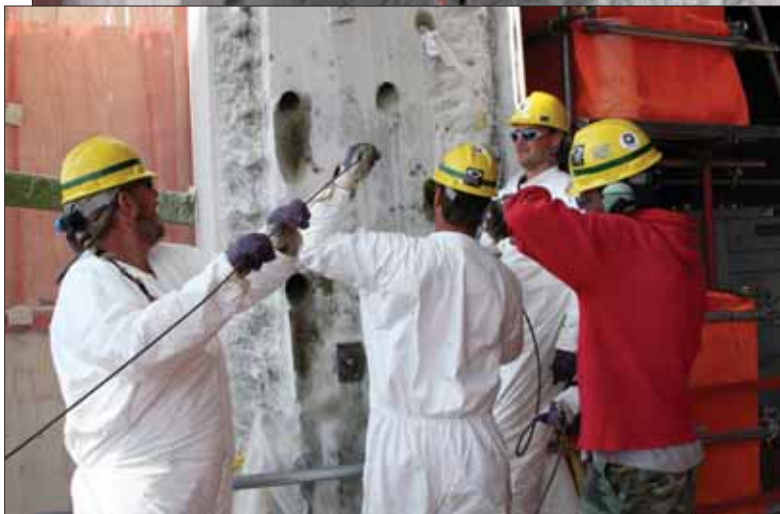
**Left:** With the containment opening created, workers clean out a channel that once contained a tendon.

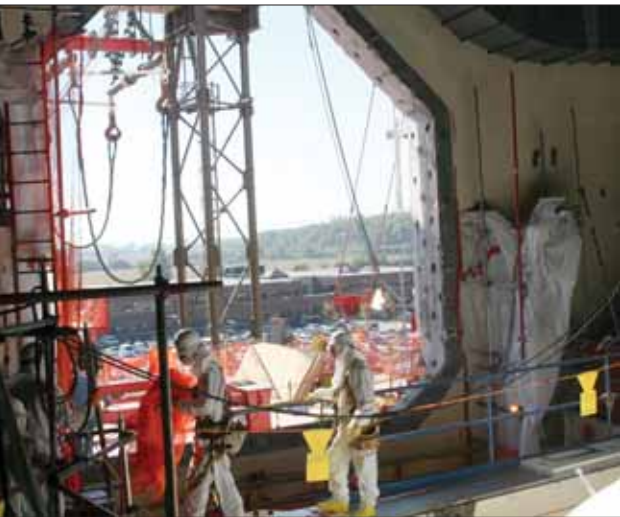
**Above:** This view is from inside the containment building looking out. Workers prepare for the moving of large components through the opening.

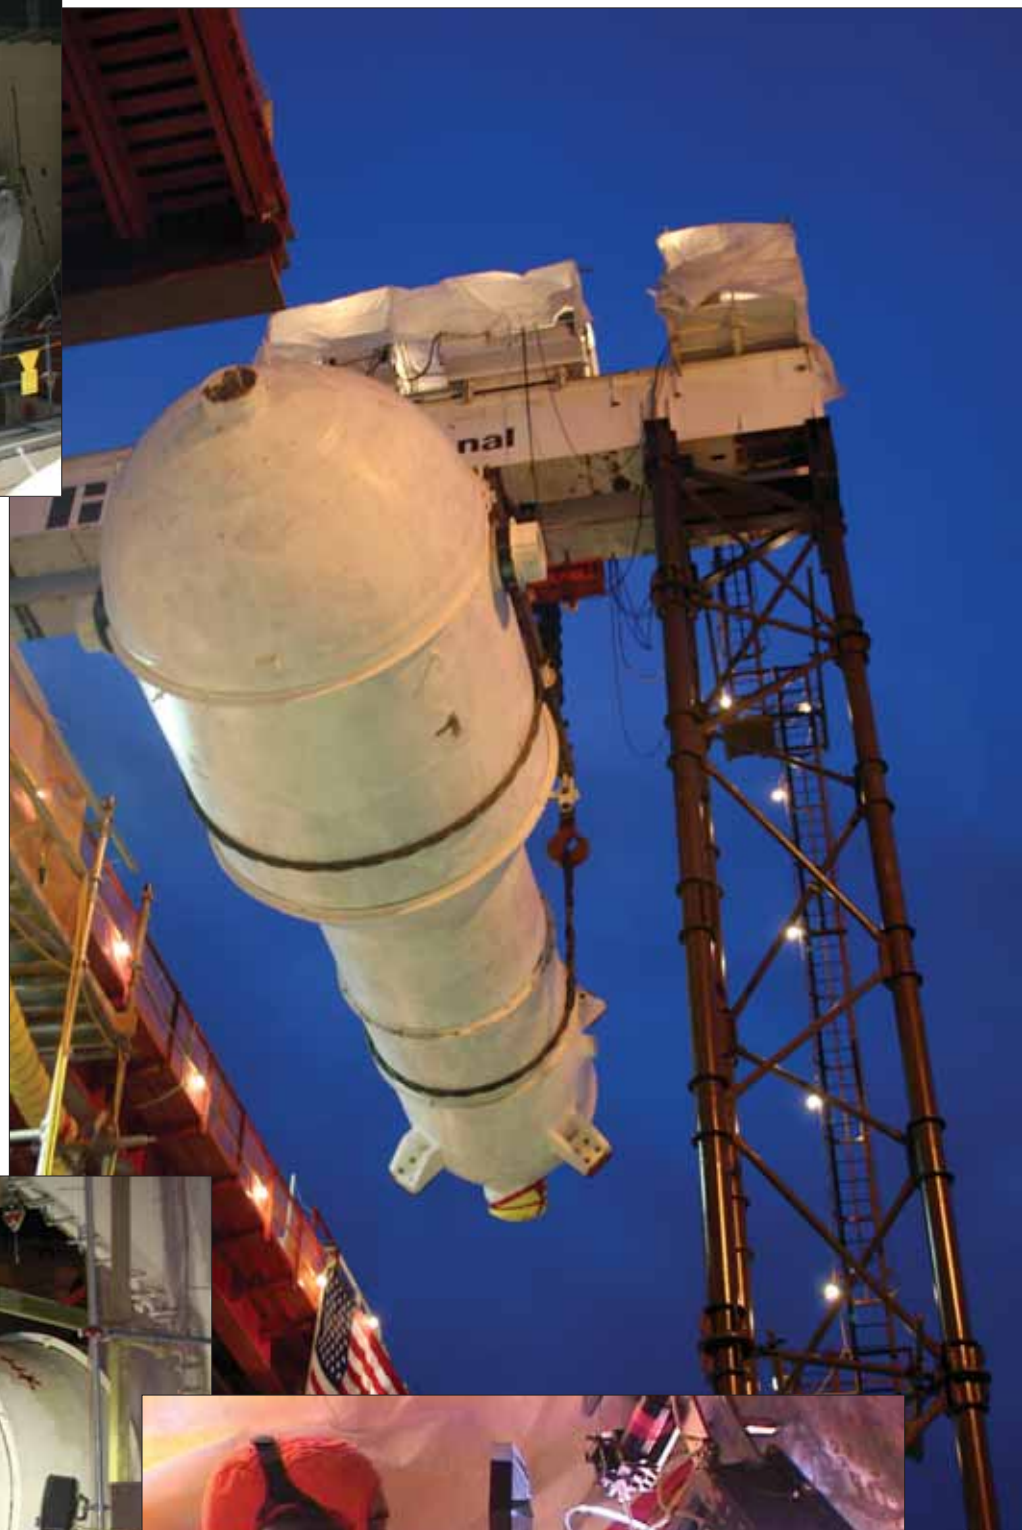
**Right:** One of the two old steam generators is removed from containment to make way for the new components. The old steam generators were moved to the ground from the holding platform, about 80 feet in the air, at a rate of 1 inch per minute.

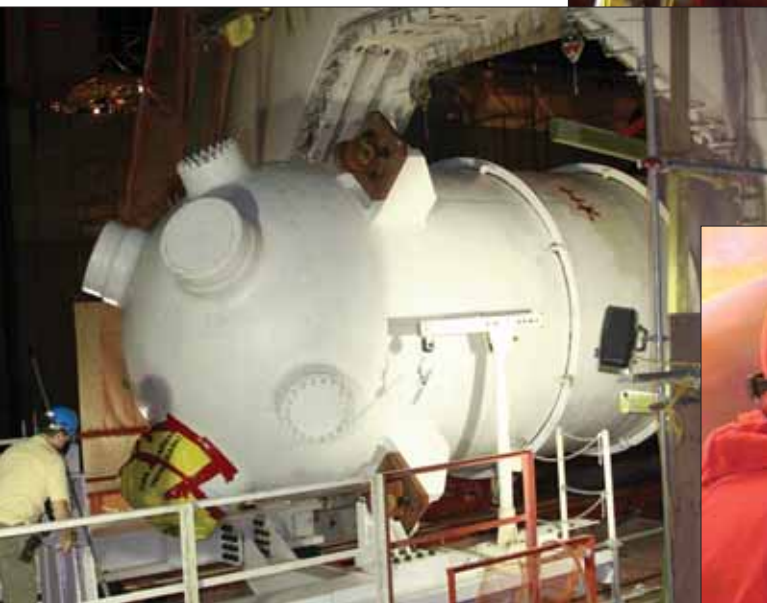
**Below:** As it makes its way out of the containment opening, an old steam generator is surveyed by the plant's Radiation Protection group.

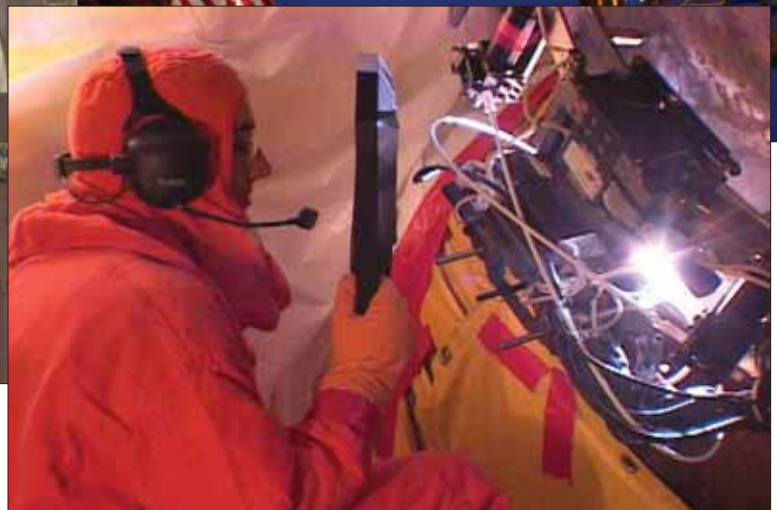
**Below right:** A worker welds one of the new steam generators into place.
